## **TreeSure Second Tree Report**

JULY 1, 2024

TREE SURVEY AND RECOMMENDED WORKS

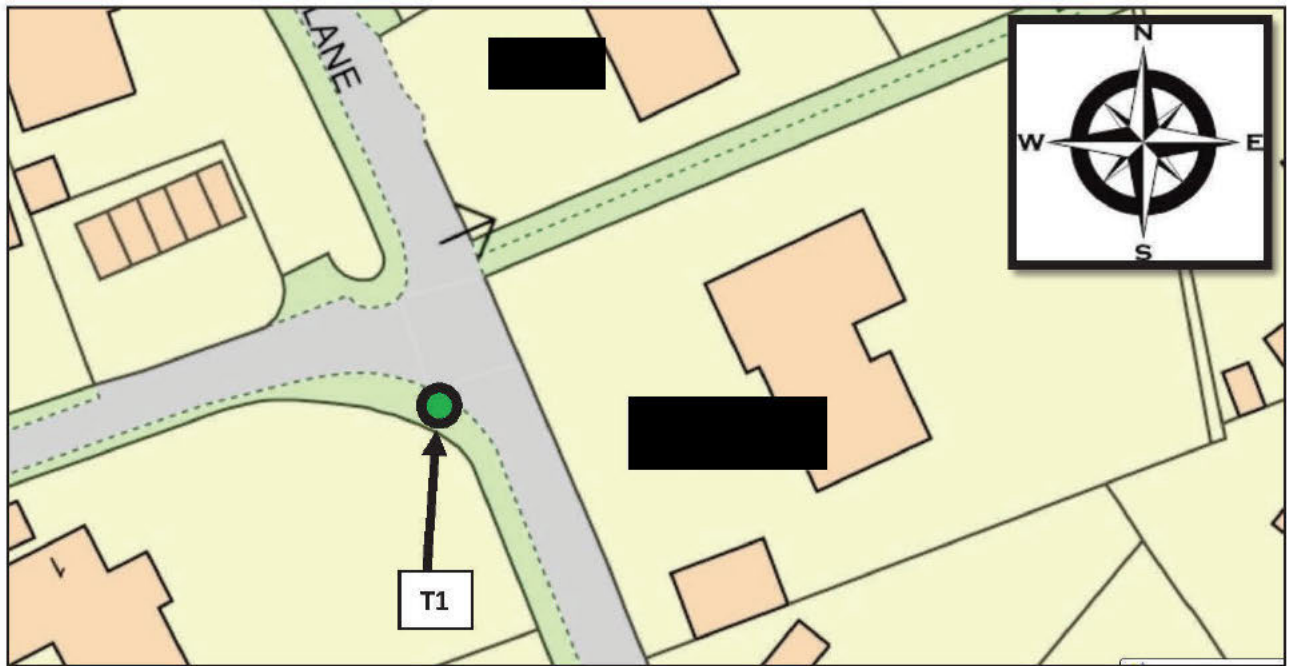
Plan 1. Location of tree on site.

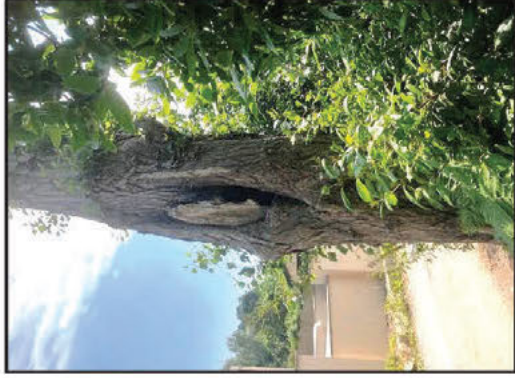
| Site: Greenfield Lane June 2024 | | | | | | | Surveyor: Guy Smallthwaite Table 1 | |
|---|---|---|---|---|---|---|---|---|
| T1 | Poplar Lombardi<br><i>Populus nigra italica</i> | 19m | 891mm | N 3<br>S 0<br>E 3<br>W3 | P | M | <p>The tree is located on the west side verge of [REDACTED] at the entrance to the Akbar and opposite the front boundary wall of [REDACTED]. It is approximately 20 metres from the house and in target range of the driveway and parking area.</p> <p>There is a large cavity in the main trunk at 2 metres. The tree was struck with a sounding hammer and audible signs of decay were evident indicating a large hollow to the base of the trunk and structural weakness.</p> | <b>Remove.</b> |

Plate 1. An image of the large cavity and evidence of hollow and advanced decay.

| Table 1. Recommended works in order of priority. | | |
|---|---|---|
| T1 Poplar Lombardi<br><i>Populus nigra italica</i> | Advanced decay at base. Remove | Urgent.<br>There is a risk of this tree failing in strong winds. |

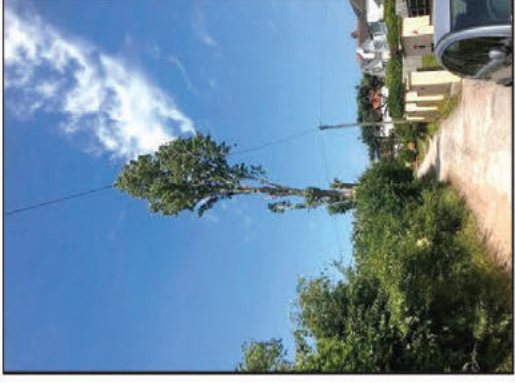
Plate 2. A view of the tree indicating imbalance and susceptibility to prevailing wind.
