TreeSure Second Tree Report

JULY 1, 2024

TREESURE

TREE SURVEY AND RECOMMENDED WORKS

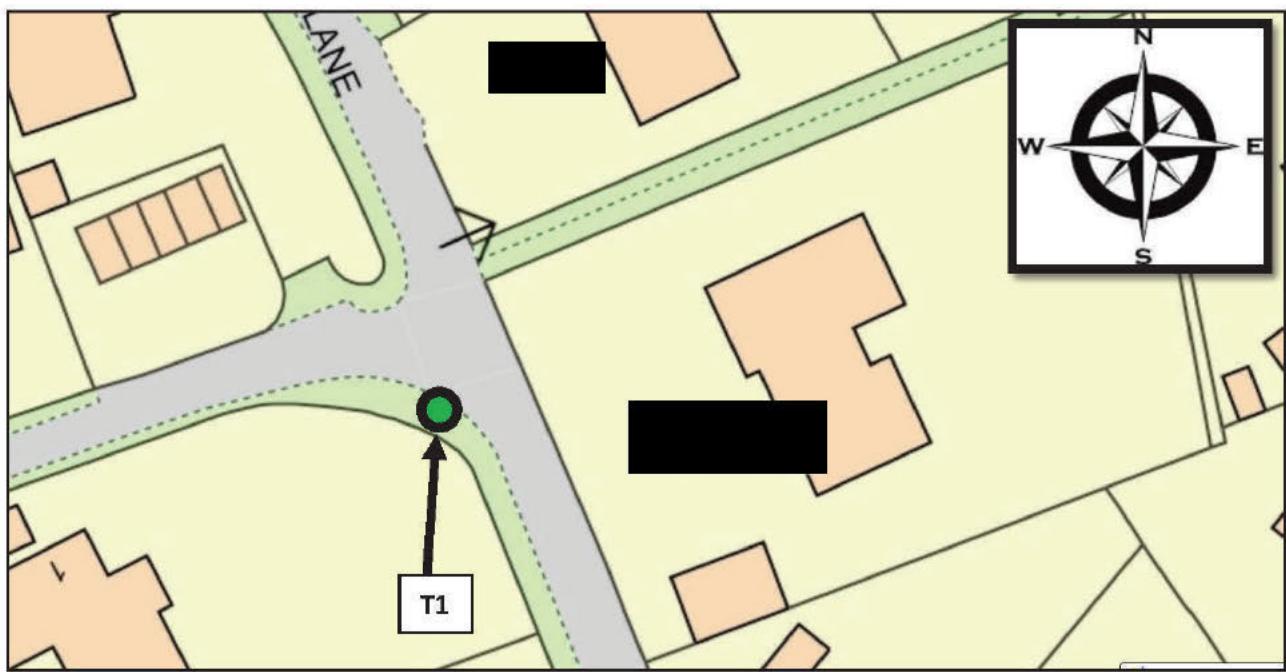
Plan 1. Location of tree on site.

Site: Greenfield Lane June 2024								Surveyor: Guy Smallthwaite Table 1	
Ref	Species	Height	Approx Stem Diameter	Cardinal points	Vitality	Age	Comments.	Management	
T1	Poplar Lombardi <i>Populus nigra</i> <i>italica</i>	19m	891mm	N 3 S 0 E 3 W3	P	M	The tree is located on the west side verge of [REDACTED] at the entrance to the Akbar and opposite the front boundary wall of [REDACTED]. It is approximately 20 metres from the house and in target range of the driveway and parking area.	Remove.

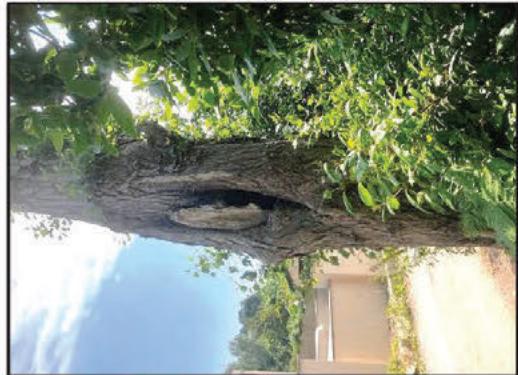
Table 1. Recommended works in order of priority.		
Individual trees and groups	Recommendations	Time Scale
T1 Poplar Lombardi <i>Populus nigra</i> <i>italica</i>	Advanced decay at base. Remove	Urgent. There is a risk of this tree failing in strong winds.

Plate 1. An image of the large cavity and evidence of hollow and advanced decay.

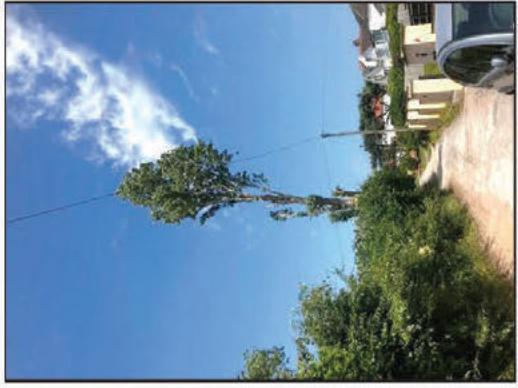
Plate 2. A view of the tree indicating imbalance and susceptibility to prevailing wind.
