## **TreeSure Second Tree Report**

JULY 1, 2024

TREE SURVEY AND RECOMMENDED WORKS

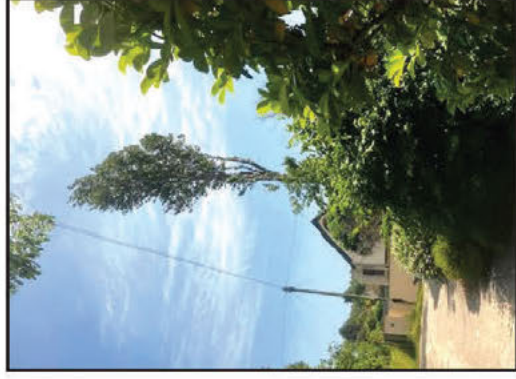
Plate 3. Image when viewed from The [REDACTED]

| Site: Greenfield Lane June 2024 | | | | | | | Surveyor: Guy Smallthwaite Table 1 | |
|---|---|---|---|---|---|---|---|---|
| T1 | Poplar Lombardi<br><i>Populus nigra italica</i> | 19m | 891mm | N 3<br>S 0<br>E 3<br>W3 | P | M | <p>The tree is located on the west side verge of [REDACTED] at the entrance to the Akbar and opposite the front boundary wall of [REDACTED]. It is approximately 20 metres from the house and in target range of the driveway and parking area.</p> <p>There is a large cavity in the main trunk at 2 metres. The tree was struck with a sounding hammer and audible signs of decay were evident indicating a large hollow to the base of the trunk and structural weakness.</p> | <b>Remove.</b> |

| Table 1. Recommended works in order of priority. | | |
|---|---|---|
| T1 Poplar Lombardi<br><i>Populus nigra italica</i> | Advanced decay at base. Remove | Urgent.<br>There is a risk of this tree failing in strong winds. |
